Geologic Setting of Mosul Dam and Its Engineering Implications

September 2007

Final report

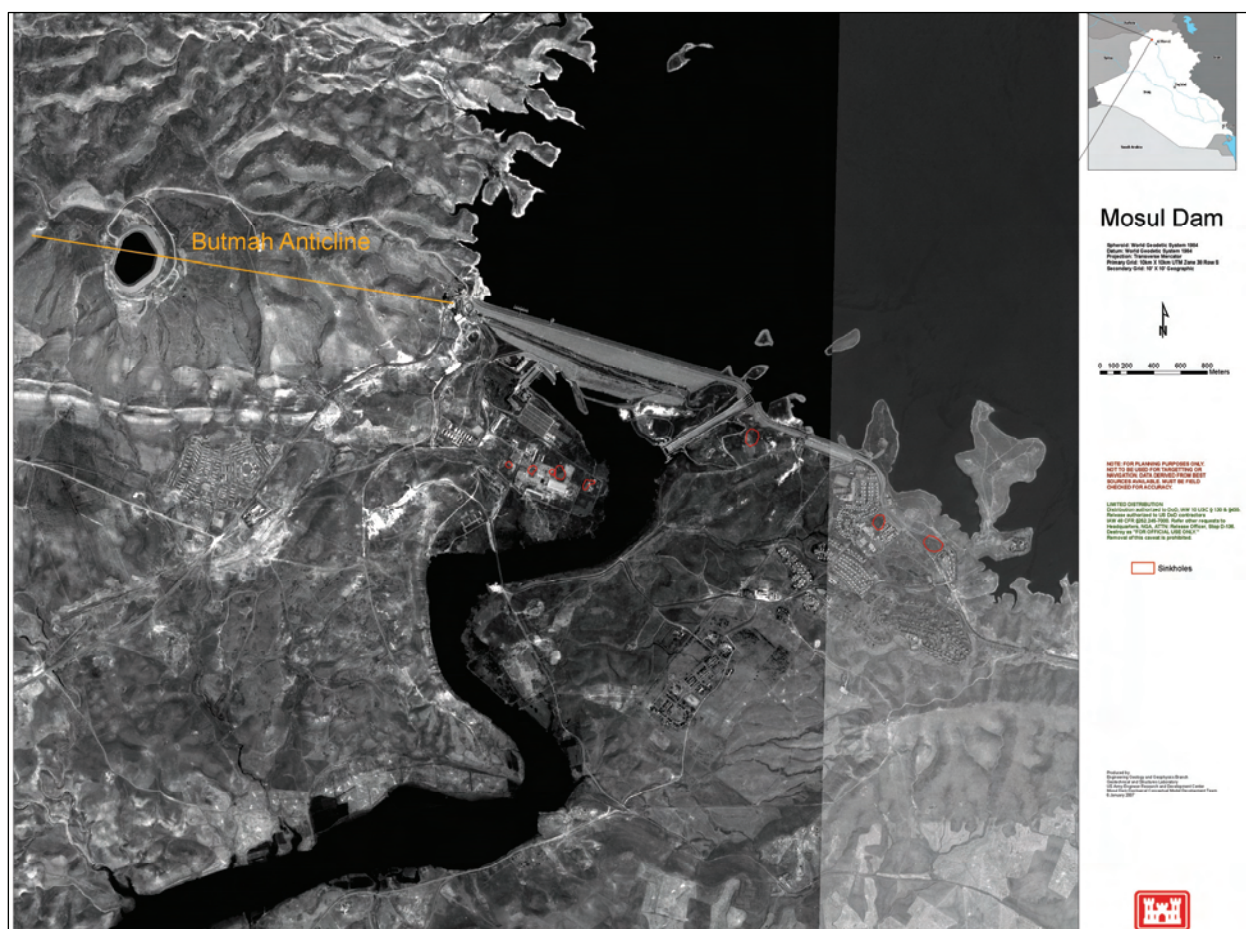
A hyperspectral image of the dam and its immediate vicinity shows a number of sinkholes that are visible downstream of the dam and on the east abutment (Figure 4). Sinkholes, caves, and cracks appeared in and around the dam foundation during construction and reservoir impoundment (in 1984). Several horizons of foundation materials are micro-fractured and highly permeable, and are undergoing dissolution. These conditions require the current and continuous grouting program that was initiated during construction in an effort to minimize further dissolution and karst development. Major functional integrity issues and concerns with the dam have always been associated with the nature of the foundation materials and with manifestations of continued dissolution such as sinkholes, seepage, and cracks in the embankment.

Figure 4. Hyperspectral image of the vicinity of Mosul Dam showing locations of sinkholes (red dots; compiled by S. Broadfoot using GIS).

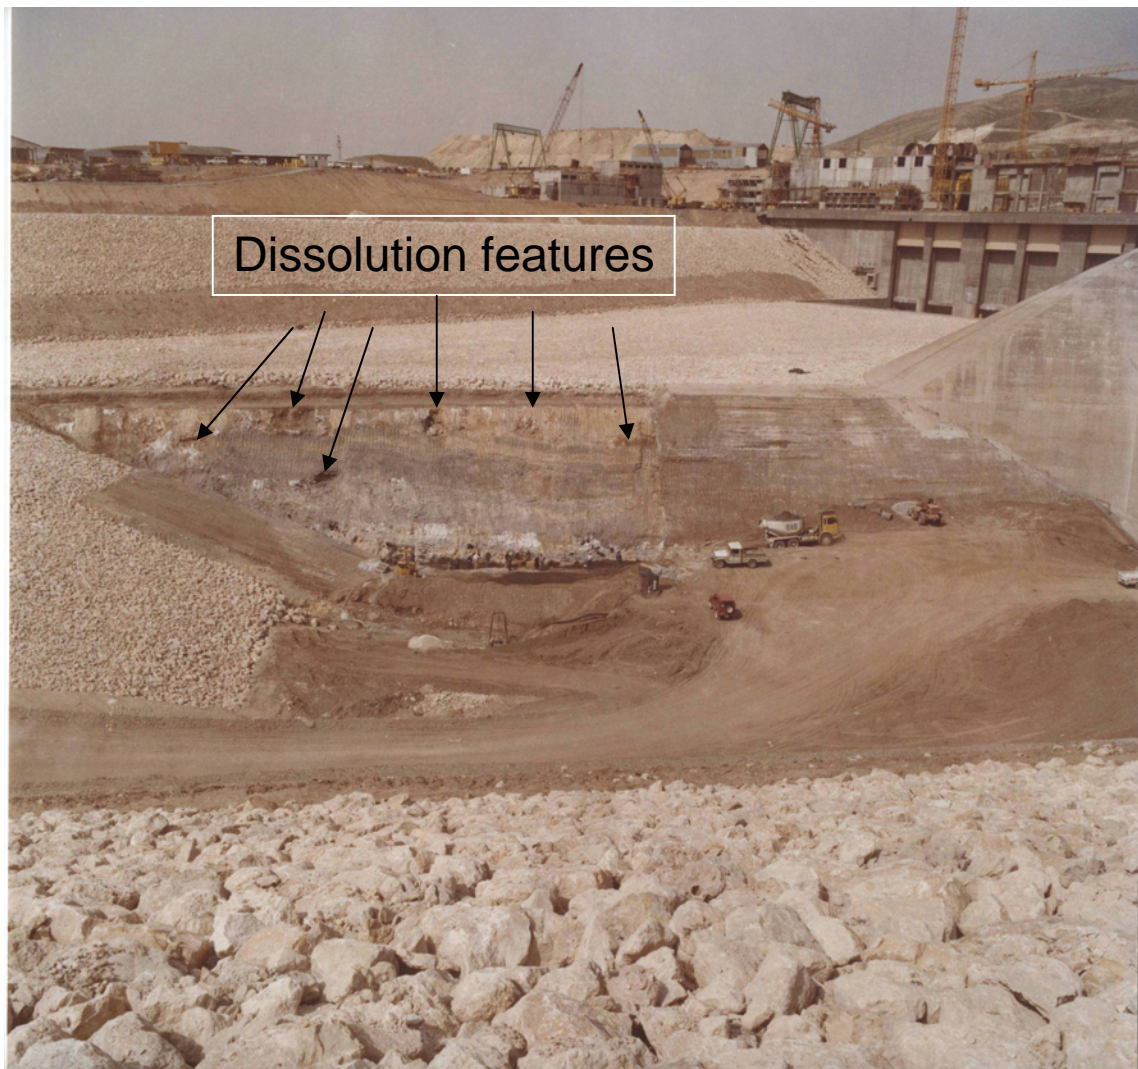
centuries to millennia before construction of the dam. This long-term dissolution is evidenced by the dissolution features visible in photos taken during construction (Ayoub 2006, photographs shown at the Sep 2006 workshop in Vicksburg, MS) (see Figure 7).

Sinkholes, caves, and cracks appeared in and around the foundation of Mosul Dam during construction and reservoir impoundment. These conditions require the current and continuous grouting program that was initiated during construction in an effort to minimize further dissolution and karst development. Major functional integrity issues and concerns with the dam have always been associated with the nature of the

Figure 7. Photo taken during construction of Mosul Dam (1982-1983) showing caves, breccia, and collapsed bedding exposed during excavation, attributed to prehistoric and historic dissolution of gypsum prior to dam construction. (Photo provided by A. T. Ayoub.)

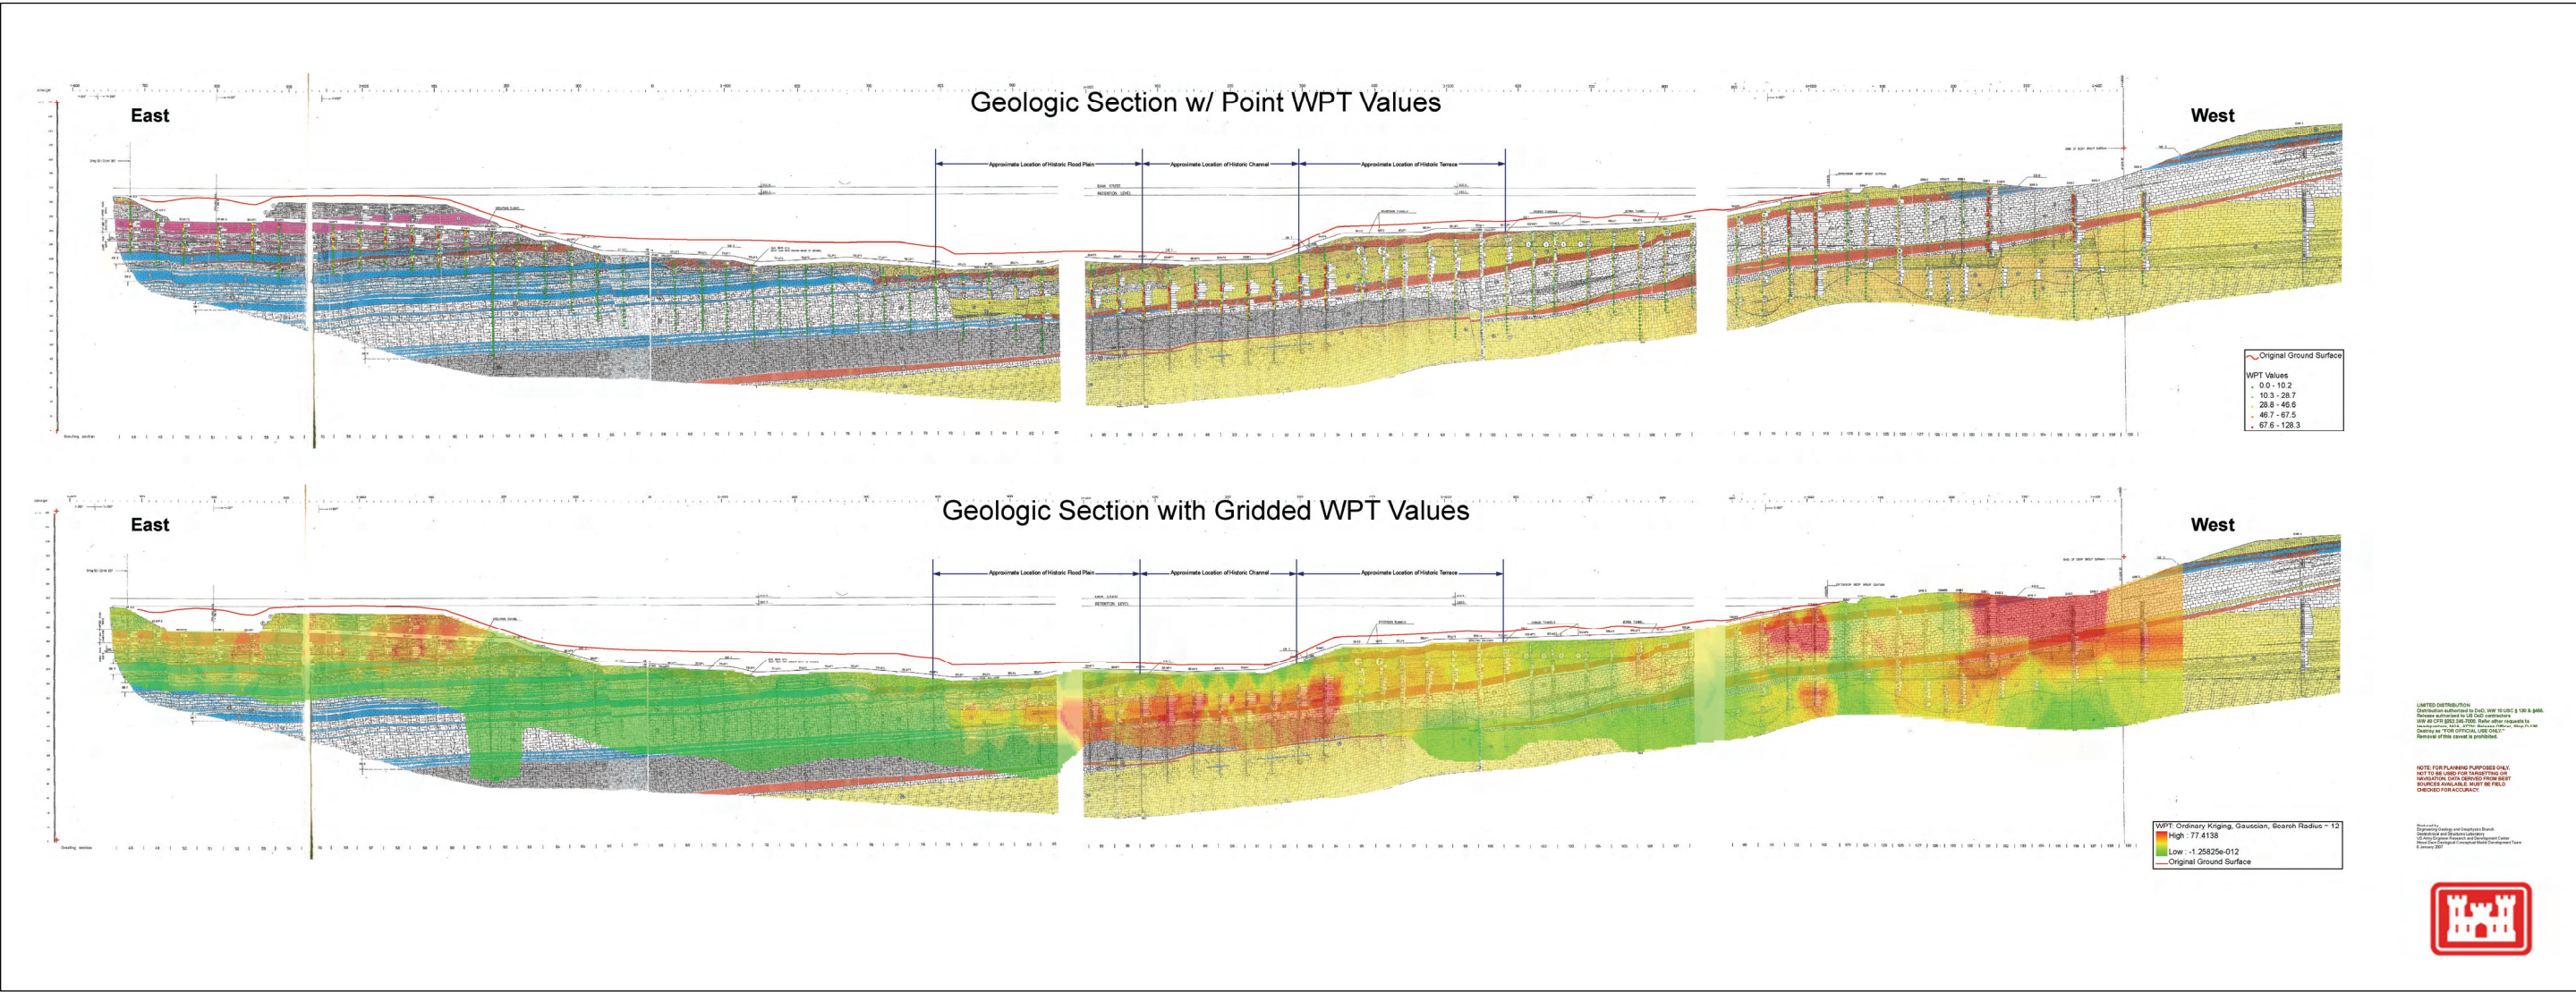
A modeling effort was completed by the ERDC team to define areas of greatest dissolution at the time of construction. Values for grout take were recorded on a cross section at the dam crest in 1984 (LOD, Vol 10). These values were plotted using Geostatistical Analyst software (ESRI) to determine a spatial correlation. A kriging procedure was used to predict unknown values from data observed at known locations with a variogram. Using this method, spatial patterns were defined to indicate ranges from high to low grout take within the foundation material. As can be observed in Figure 8, the highest grout take (shown in red) is located within the historic river channel. Other areas of high grout take were within the highly permeable F-bed Limestone.

Figure 8. Geologic sections with water-pressure test values (upper figure) and kriging statistical analysis (lower figure) indicating areas of dissolution at the time of construction. The sections are from boreholes of the grout gallery under the dam. In the kriging (lower) section, red areas indicate zones of prehistoric and historic dissolution (M. L. Pearson, S. W. Broadfoot, J. R. Kelley, and T. E. McGill).

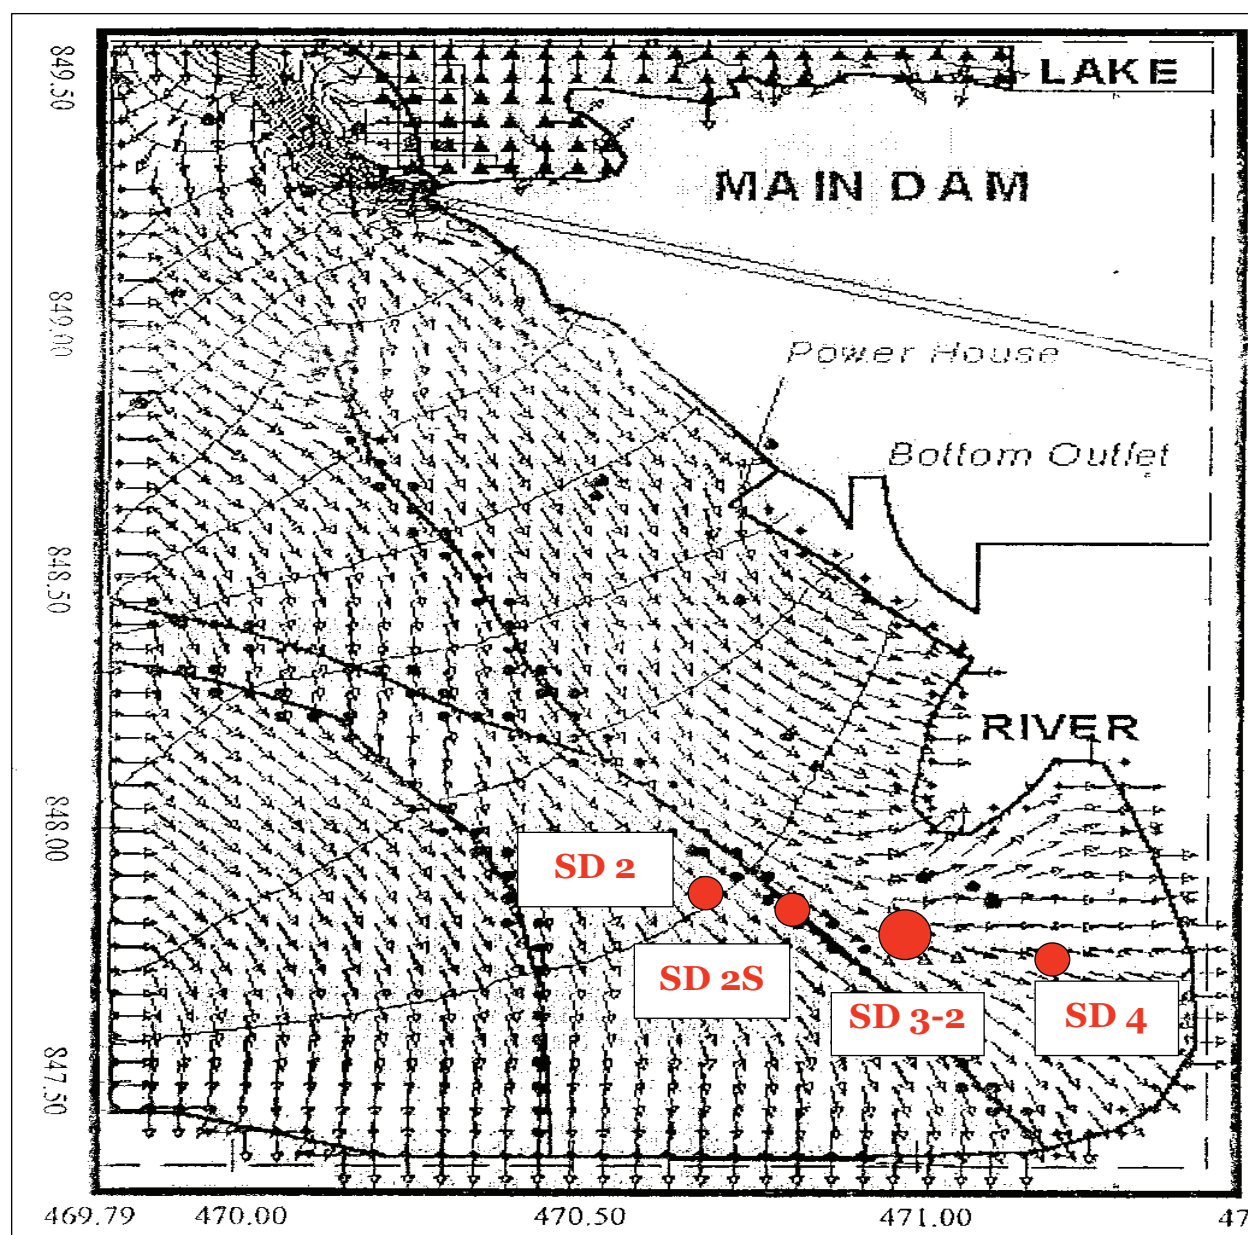
Four sinkholes (SD2, SD2S, SD3, and SD4) formed between 1992 and 1998 approximately 800 m downstream in the maintenance area of the dam (west abutment; LOD Final Report). The development of the sinkholes began with the appearance of concentric tension cracks followed

by settlement. The sinkholes appeared in a linear arrangement, approximately parallel to the dam axis. Sinkhole SD4 was excavated and observed for a year. The water level in this sinkhole did not fluctuate with changes in the reservoir level, but was sensitive to changes in the tailwater level. Fluctuating groundwater levels can lead to sinkhole development. Where an existing void or cavern has formed, the soil above has been alternately saturated and drained, resulting in reduction in pore pressure and eventual collapse.

Figure 9. Drainage net provided by Mosul Dam staff indicates flow toward sinkholes in downstream maintenance area (sinkholes in red; modified by M. L. Pearson and J. R. Kelley).

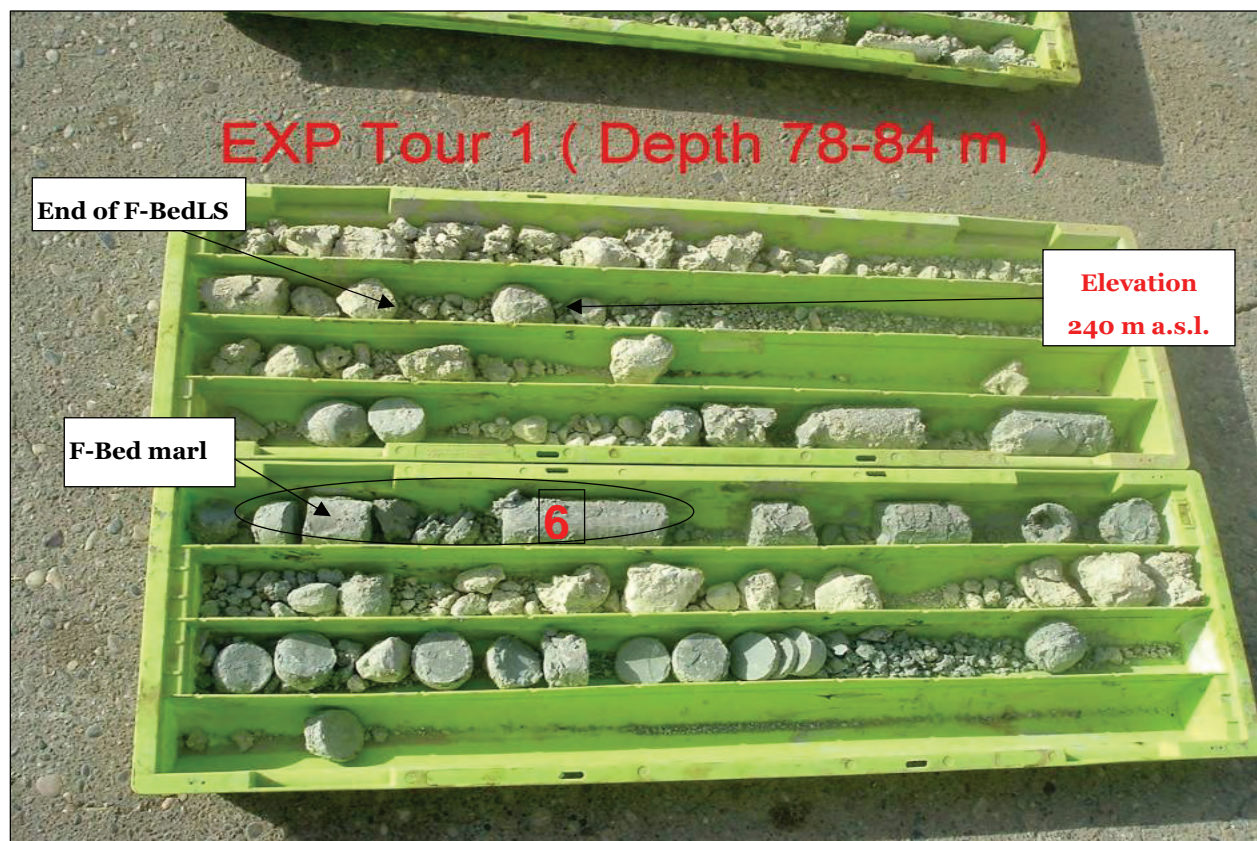
Figure 10. Core recovered from near sinkhole in residential area in 2006. Very small pieces of core and missing segments indicate RQD at or near zero, very poor rock quality.

that was considered competent to support the spillway and saddle dam during construction has deteriorated and may no longer be competent.

The appearance of a previously unknown sinkhole near the spillway crest in 2005 also shows this very active dissolution and degradation of rock quality in the east abutment. The potential for failure of the east (left) abutment has increased since construction.

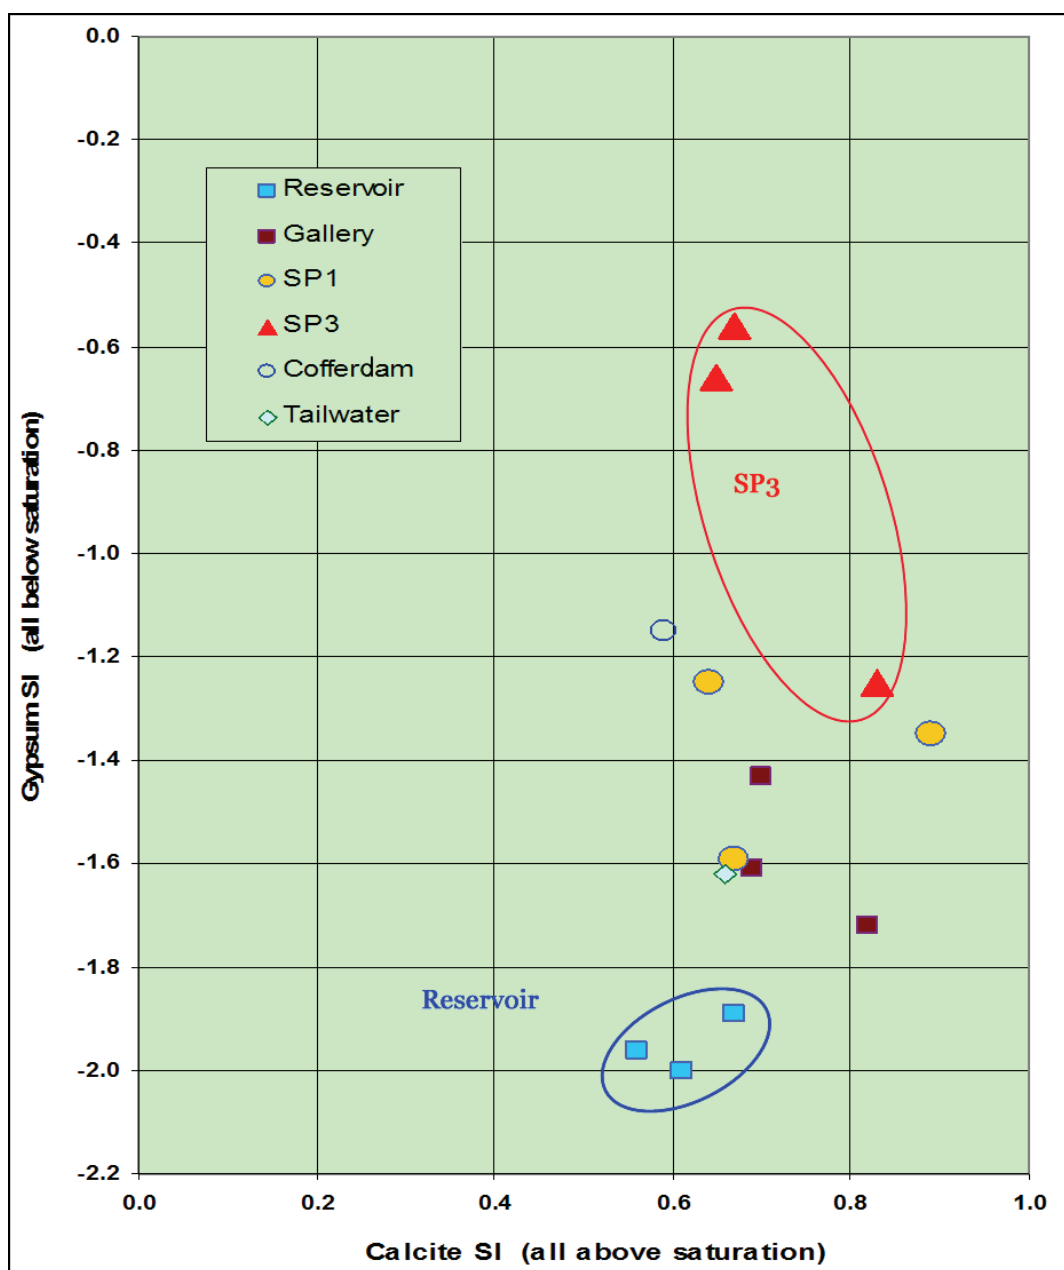
Data for groundwater chemistry available for the ERDC study show that the water is undersaturated with respect to gypsum, although some interesting trends are evident (Table 3 and Figure 12). The analyses that most closely approach equilibrium are in samples associated with the east abutment. That is, less-negative values for saturation of SP3 water with gypsum (red oval in Figure 12) correspond to the removal of gypsum from the abutment and the increase in dissolved gypsum in seep water relative to reservoir water.

Figure 12. Chemical compositions of reservoir water and seep waters as represented by their saturation indexes for calcite (abscissa) versus gypsum (ordinate). Less-negative values for saturation of SP3 water (red oval) with gypsum correspond to the removal of gypsum from the abutment and increase in dissolved gypsum in seep water relative to reservoir water.
